A HYDROGEOLOGICAL INVESTIGATION  
OF THE CLOSED NORWICH  
WASTE DISPOSAL AREA  
IN NORWICH, ONTARIO

A HYDROGEOLOGICAL INVESTIGATION  
OF THE CLOSED  
NORWICH WASTE DISPOSAL AREA  
IN NORWICH, ONTARIO  
(No. 070701)

Report Prepared for:  
Waste Management Branch

Report prepared by:  
R. Blackport  
B. Boyle

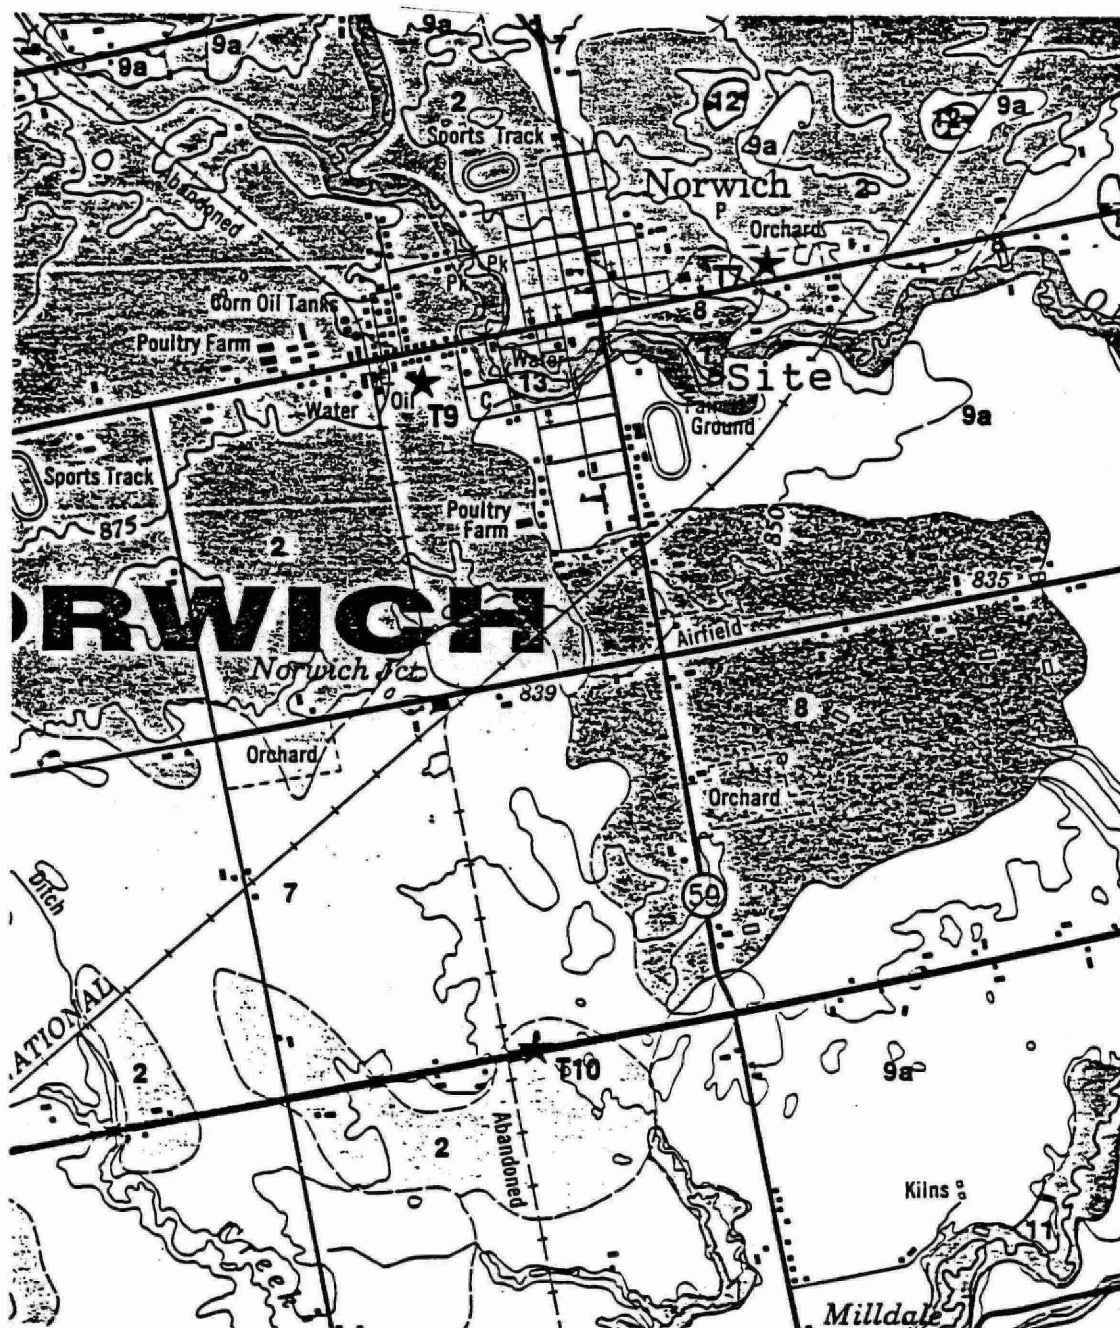
## FIGURE 4 QUATERNARY GEOLOGY

Mapping of the Quaternary geology by Barnett (1982) indicates that the Catfish Creek Till, a stony sandy silt till, underlies the landfill. The site is apparently bounded by glaciolacustrine deepwater deposits (massive to laminated silt, minor clay) to the north, and by modern alluvial deposits (clay, silt, sand and muck) to the south and west (Figure 4).
